# Why the Afterbody Went Flying

By AD2(AW) Randy Penrod

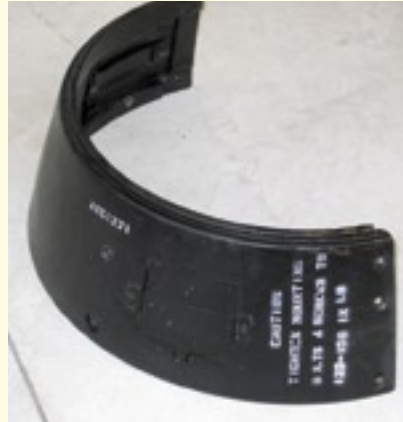
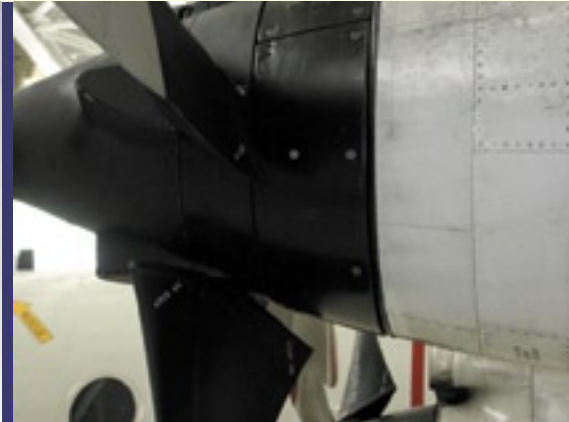
Within seconds of returning to my shop, the maintenance chief called, saying the afterbody fell off the aircraft. My heart sank, and I could not believe it! I immediately proceeded out to the aircraft and saw that my team had failed to install the bolts, allowing the afterbody to fall free during the turn.

An unsecured afterbody can become a missile.

and had failed to recognize I was the CDI and started the engines again without confirming the afterbodies were installed or completing another walk-around inspection.

As the CDI, I should have let the FE know that I was heading into the hangar to sign off MAFs and my workers were installing the afterbodies. My workers should have told the FE that the installation had not been CDI'd and should have had the situational awareness to stop the turns, knowing I had not signed off on their work.

The FE, noticing the petty officers no longer were working on the afterbody, assumed the work was done. Instead of talking to someone or checking the work, he proceeded to turn the engine.
